Infiltration Test Report

Project:	University of Colorado Anschutz Medical Campus – R2 Indoor Air Quality Assessment	Subject:	Findings and Recommendations
CRA Project #:	2019-169	Date:	May 8, 2019
Client:	Mike Barden	Time:	10:00 a.m.
Observers:	Joshua Harwood/Sean Convery

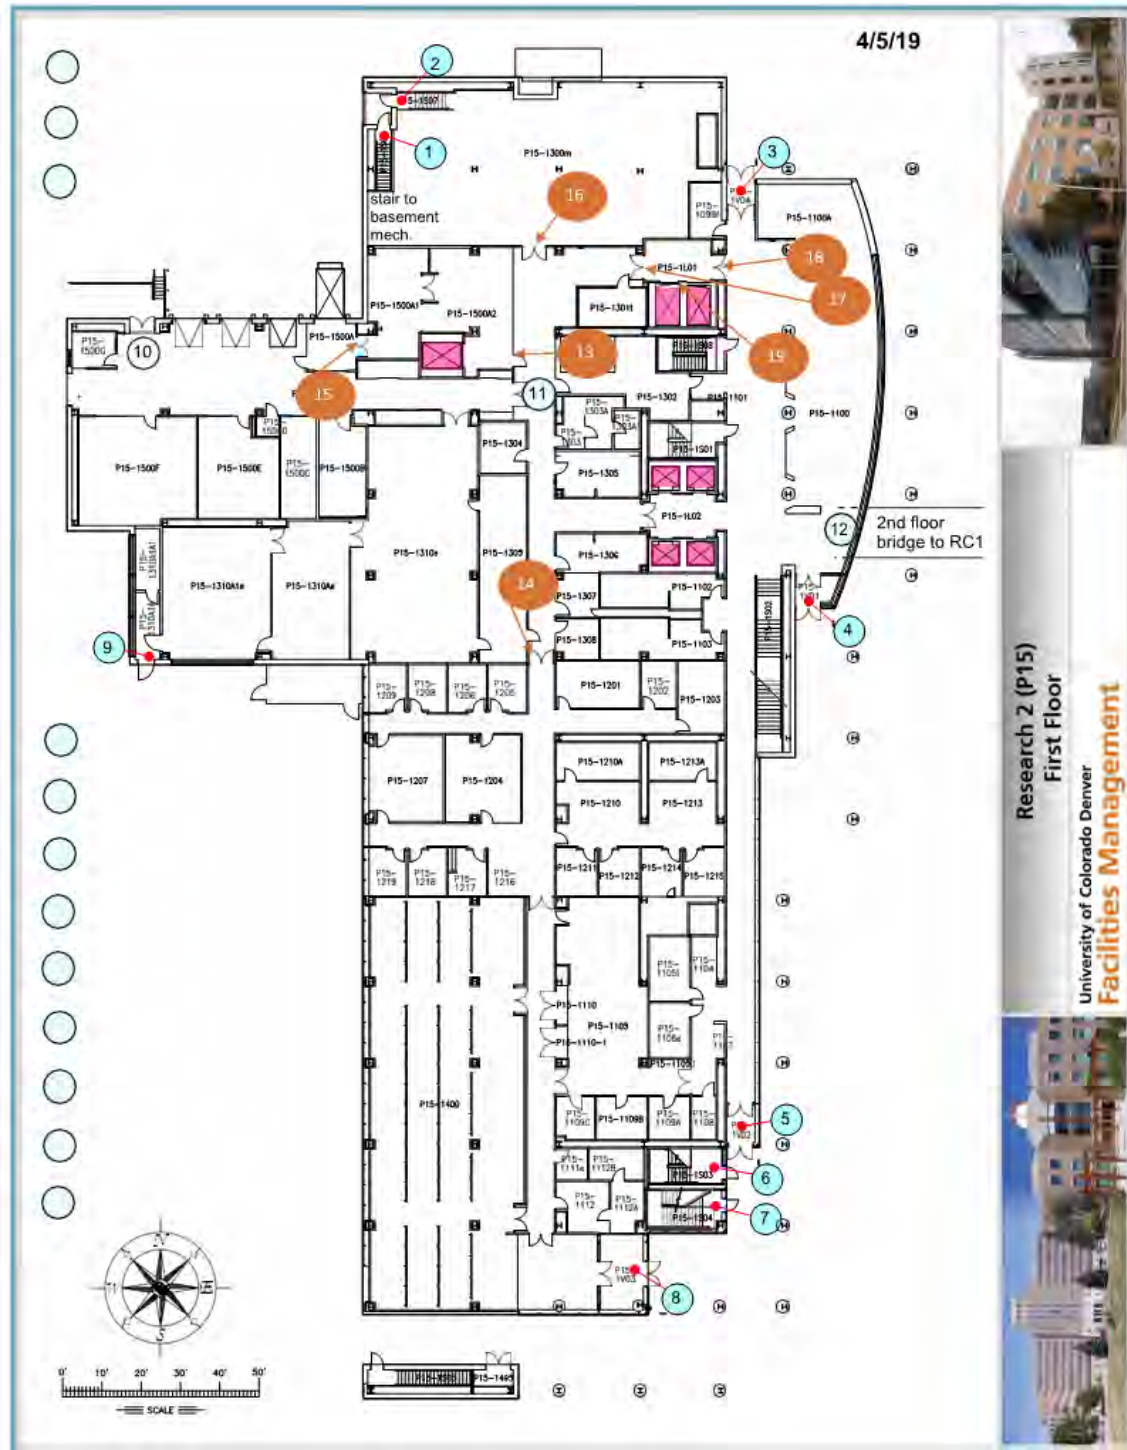
The diagram below illustrates the locations of pressure testing:

The following table should be correlated with the diagram above. The table contains values that the UCD facilities team observed during their survey on April 5, 2019. CRA also surveyed these locations in addition to some additional locations (indicated by the orange colored bubbles). All pressure readings were taken in inches of water column (iwc).

Pressure Survey ID	High Pressure Reference Location	Low Pressure Reference Location	4/5/19 Pressure Reading iwc	5/8/19 Pressure Reading iwc	Notes
1	Ambient	Inside the stairwell	0.017 to 0.025	0.02	Negative to ambient
2	Ambient	Inside the mechanical room	0.008 to 0.013	0.02	Negative to ambient
3	Ambient	Inside the N main lobby vestibule	0.011 to 0.025	0.03 to 0.04	Negative to ambient Vestibule doors held open to the building during testing. Every effort was made to ensure other exterior doors were closed during test.
4	Ambient	Inside the S main lobby vestibule	0.011 to 0.031	0.03 to 0.05	Negative to ambient Vestibule doors held open to the building during testing. Every effort was made to ensure other exterior doors were closed during test.
5	Ambient	Inside the S corridor vestibule	0.022 to 0.051	0.048	Negative to ambient Vestibule doors held open to the building during testing. Every effort was made to ensure other exterior doors were closed during test.

6	Ambient	Inside the stairwell	0.022 to 0.051	Not surveyed	Negative to ambient
7	Ambient	Inside the stairwell	0.01 to 0.026	Not surveyed	Negative to ambient
8	Ambient	Inside the vestibule	0.01 to 0.015	Not surveyed	Negative to ambient
9	Ambient	Inside the loading dock vestibule	Neutral to 0.001	Not surveyed	Neutral to ambient
10	Ambient	Inside the loading dock area	Neutral	0.01	Negative to ambient
11	Loading dock	Corridor (back of house)	0.018 to 0.029	0.06	Corridor negative to dock area
12	2 nd floor lobby	Pedestrian bridge to R1 building	0.032 to 0.038	0.06 to 0.07	R1 is negative to R2
13	Corridor	Vivarium elevator lobby	Not surveyed	0.009	Neutral to vivarium elevator
14	North side of the double doors	South side (freezer farm side)	Not surveyed	0.01	Negative towards the main building elevators
15	Vivarium elevator lobby	Loading dock	Not surveyed	0.03	Vivarium elevator lobby is negative to the loading dock

16	Mechanical Room	Corridor (back of house)	Not surveyed	0.006	Slight negative towards the building
17	Freight Elevator lobby	Corridor (back of house)	Not surveyed	0.005	Slight negative to elevator lobby with the double doors closed
18	Freight Elevator lobby	Main L1 lobby	Not surveyed	0.004	
19 1 st floor	Freight Elevator Lobby	Elevator shaft	Not surveyed	0.006 to 0.01	Freight Elevator shaft is slightly negative to lobby. Observed more negative as elevator rose. The shaft is common to both cars.
19 7 th floor	Freight Elevator Lobby	Elevator shaft	Not surveyed	0.001 to -0.003	The pressure gradient flipped when the car rose from below. The shaft is generally slightly negative to the lobby when the cars are idle
